# Manhole Inspection Summary

Manhole # S53M\_\_015MH

Insp Date: **4/3/08 2:24 PM**

**Location** Address: **939 Dillion St**

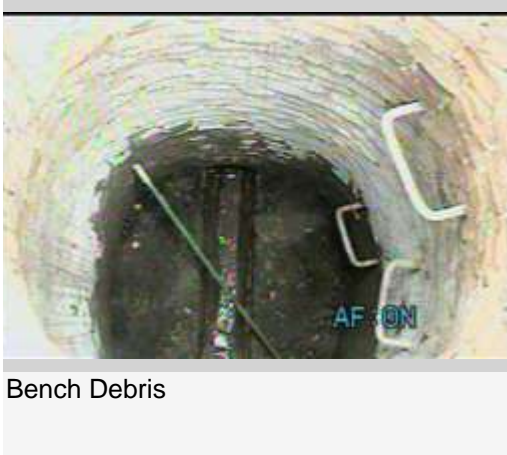
Defect 2

Condition: ☐ Sound ☐ Cracked ☐ Root Intrusion ☐ Deteriorated ☐ Leaks ☒ **Debris**

Bench Debris

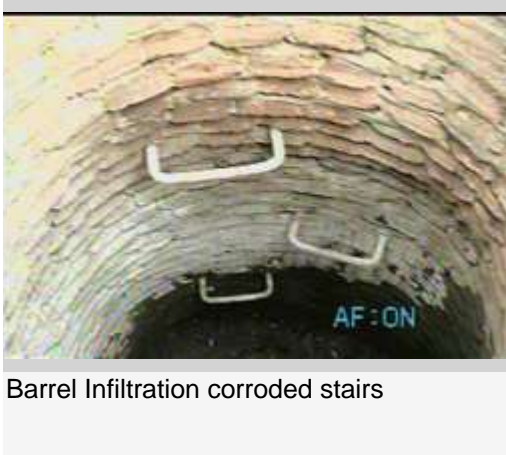
Defect 1

Infiltration: ☐ None ☐ Joint ☐ Cracks ☐ Mortar ☐ Roots ☒ **Wall**

**Steps** Count: **3** Missing: **0** ☒ **Corroded**

Barrel Infiltration corroded stairs

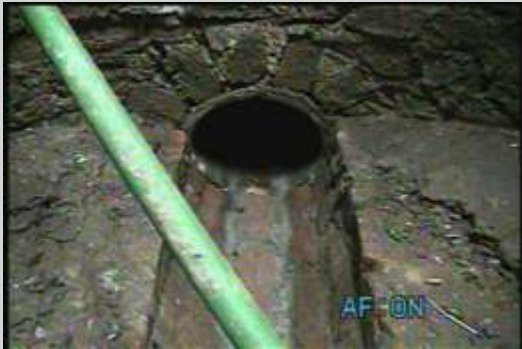
12 O'Clock Outflow

8 in. Circular Gravity Sewer  
Pipe Out @ 12 O'Clock

Invert Depth: **8.08** (ft.) Flow Characteristics: **Slow**

Deposits: ☒ None ☐ Mud ☐ Sludge ☐ Debris ☐ Grease

Infiltration: **None** Pipe Seal Cond: **Unknown**

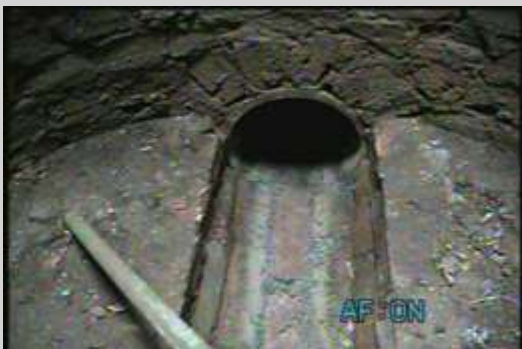
6 O'Clock Inflow

10 in. Circular Gravity Sewer  
Pipe In @ 6 O'Clock

Invert Depth: **7.72** (ft.) Flow Characteristics: **Slow**

Deposits: ☒ None ☐ Mud ☐ Sludge ☐ Debris ☐ Grease

Infiltration: **None** Pipe Seal Cond: **Unknown**
